## Three Stories Masonry Wall Capacity and Behavior Second Progress Report

by Fernando S. Fonseca, Ph.D., S.E. and Ernesto Fortes, Jeff Buxton, David Ochoa, and Kyle Chavez, Graduate Students

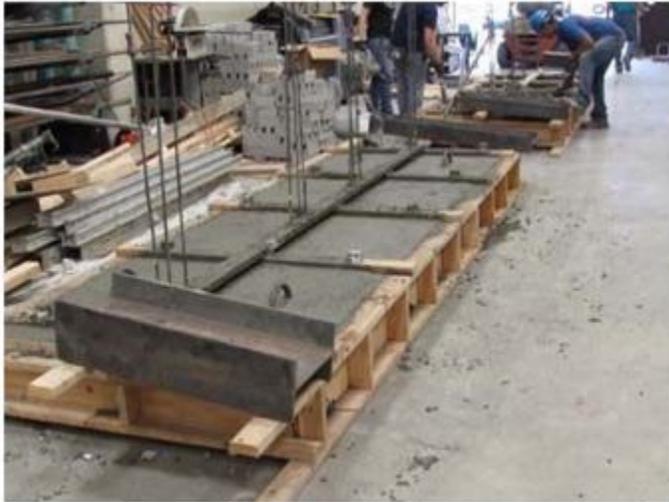
Construction of each wall began with casting a reinforced concrete footing measuring approximately 305 mm × 1219 mm x 4064 mm as shown in Figure 1.

Figure 1 - Reinforced concrete footing

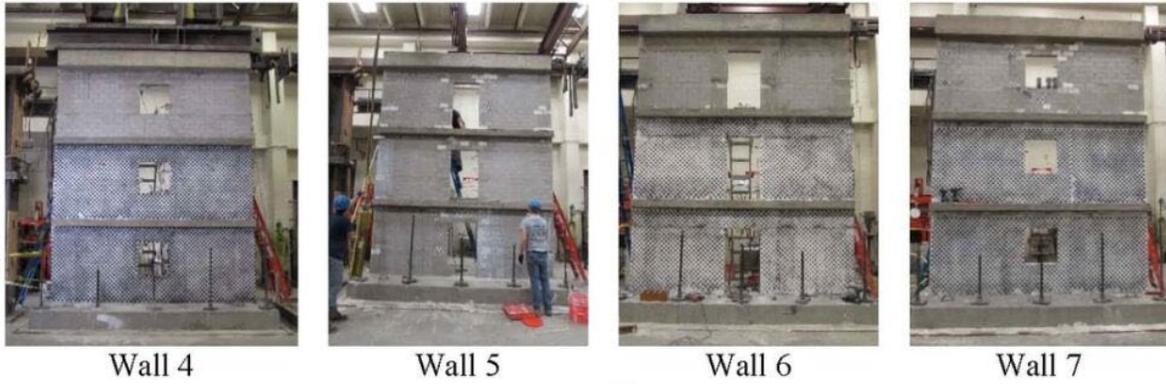
The specimens are half-scale and the designs represent a three-story shear wall. Wall 4 has windows in the center of the wall as shown in Figure 2. Walls 5 and 6 have doors but wall 5 has a masonry beam above the doors while wall 6 has a reinforcement concrete T-beam.

Figure 2- walls tested

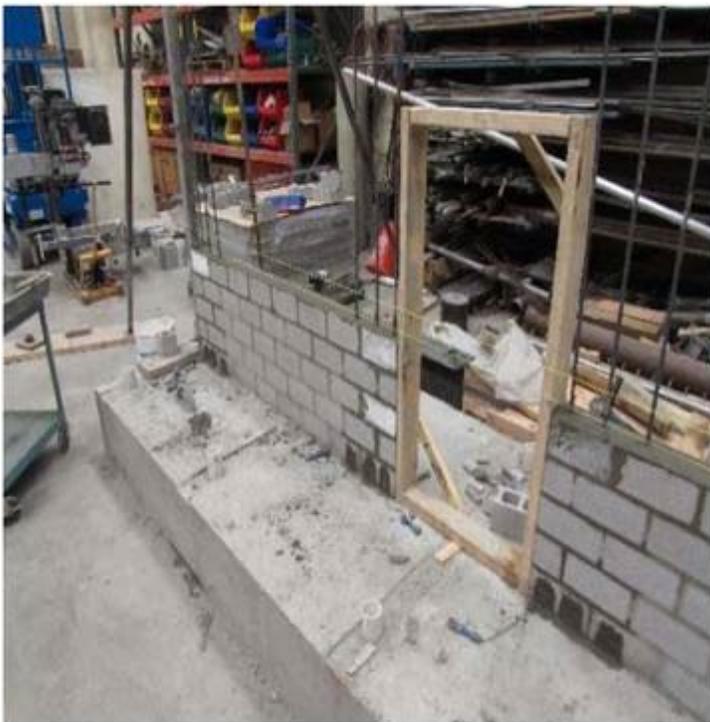
Researchers made a slight change on the design of the walls (from the previous walls) in an attempt to improve their behavior. A bond beam, as shown in Figure 3, has been added on the fifth course of every wall.

Figure 3 - Bond Beam at the fifth course

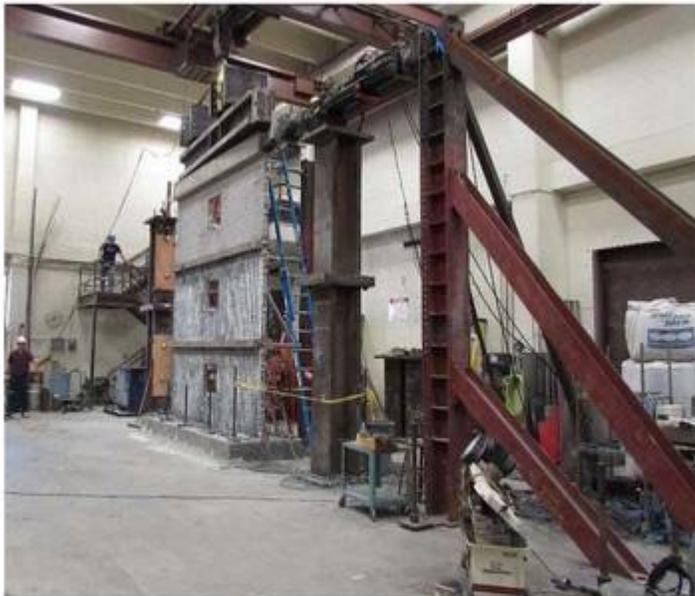
Walls were tested using a custom reaction/testing frame that allows the MTS actuator to push and pull the walls cyclically at increasing loads and/or displacements as shown in Figure 4. The walls were instrumented with LVDTs, string pots, and strain gauges as shown

Figure 4 - : Reaction/Testing Frame

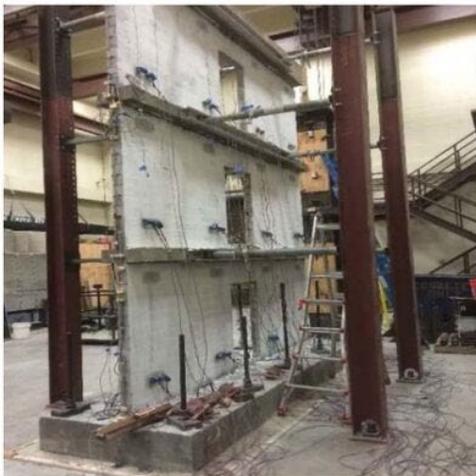
in Figure 5. After each push or pull, cracks were documented to track their development and propagation as shown in Figure 6.

Figure 5 - Instrumentation

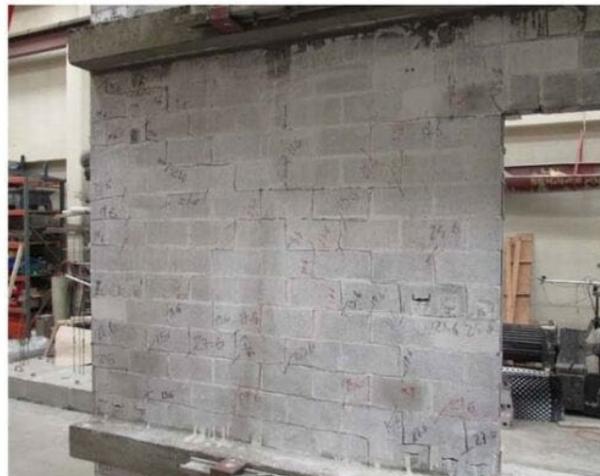
Figure 6 – Crack Pattern

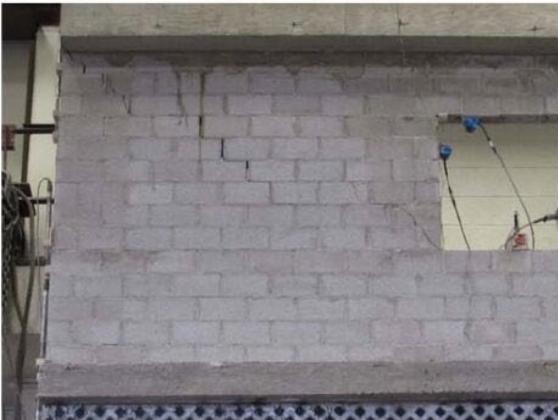
All walls experienced a shear failure. Wall 4 (with windows) failed in the third story as shown in Figure 7. Wall 5 (with doors and a masonry beam above the doors) also failed in the third story as shown in Figure 8. Wall 6 (with doors and a reinforcement concrete T-beam above the doors) failed in the third story as well as shown in Figure 9. Wall 7 (with windows) in the first story as shown in Figure 10.

Figure 7 – Failure of Wall 4

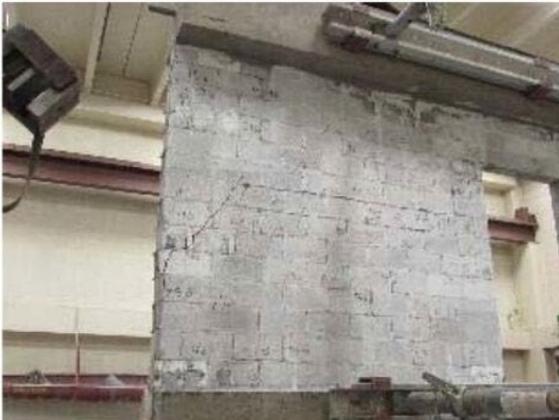
Figure 8 – Failure of Wall 5

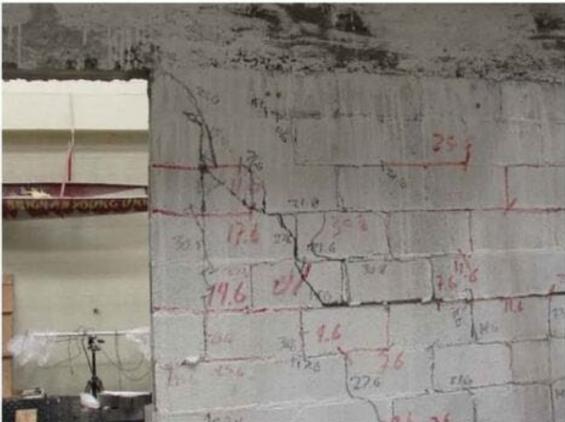
Figure 9 – Failure of Wall 6

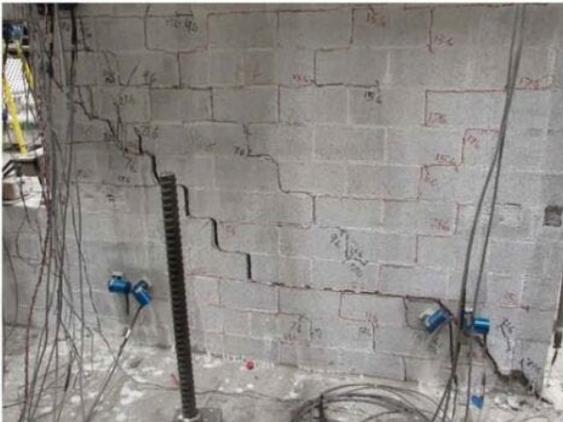
Figure 10 – Failure of all 7

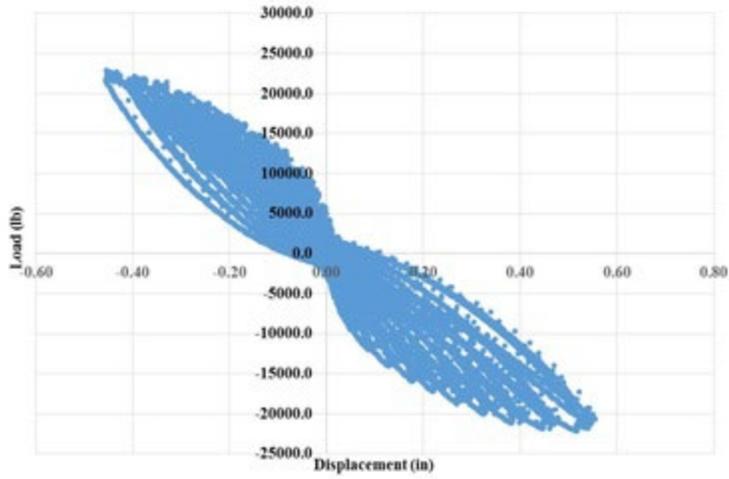
Load-Displacement Relationships Figure 11 to Figure 14 shows the load-displacement relationship, as measured at the top of the wall, for walls 4, 5, 6, 7, respectively.

Figure 11 - Load-Displacement Relationship for the Wall 4

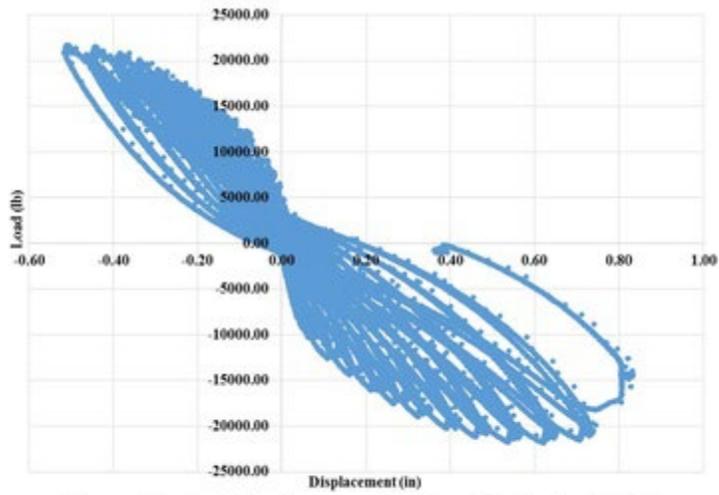
Figure 12 - Load-Displacement Relationship for the Wall 5

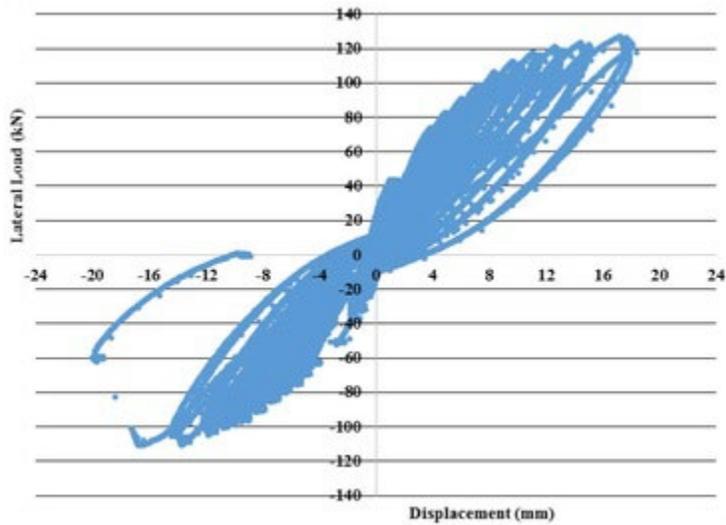
Figure 13 - Load-Displacement Relationship for the Wall 6

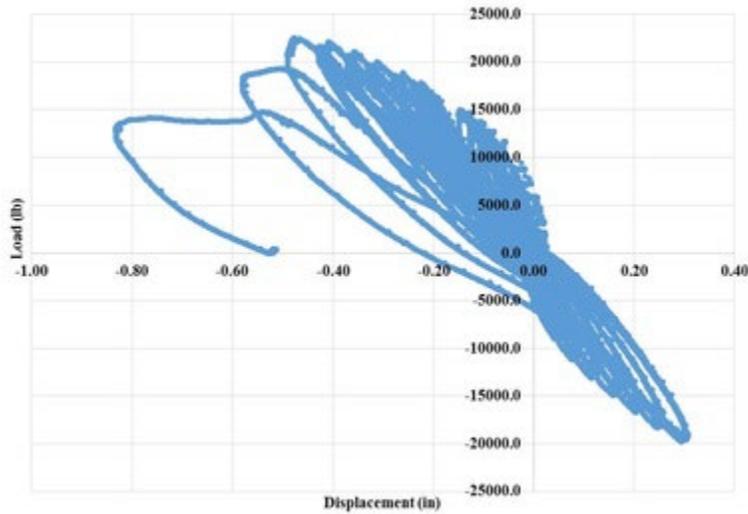
Figure 14 - Load-Displacement Relationship for the Wall 7
